HYDROGEOLOGICAL ASSESSMENT OF CENTENNIAL PARK WASTE DISPOSAL SITE, TRENTON (No. 360201) NOVEMBER 1988

Report prepared for:
Waste Site Evaluation Unit
Waste Management Branch

Report prepared by:
Water and Earth Science Associates Limited

JUNE 1989

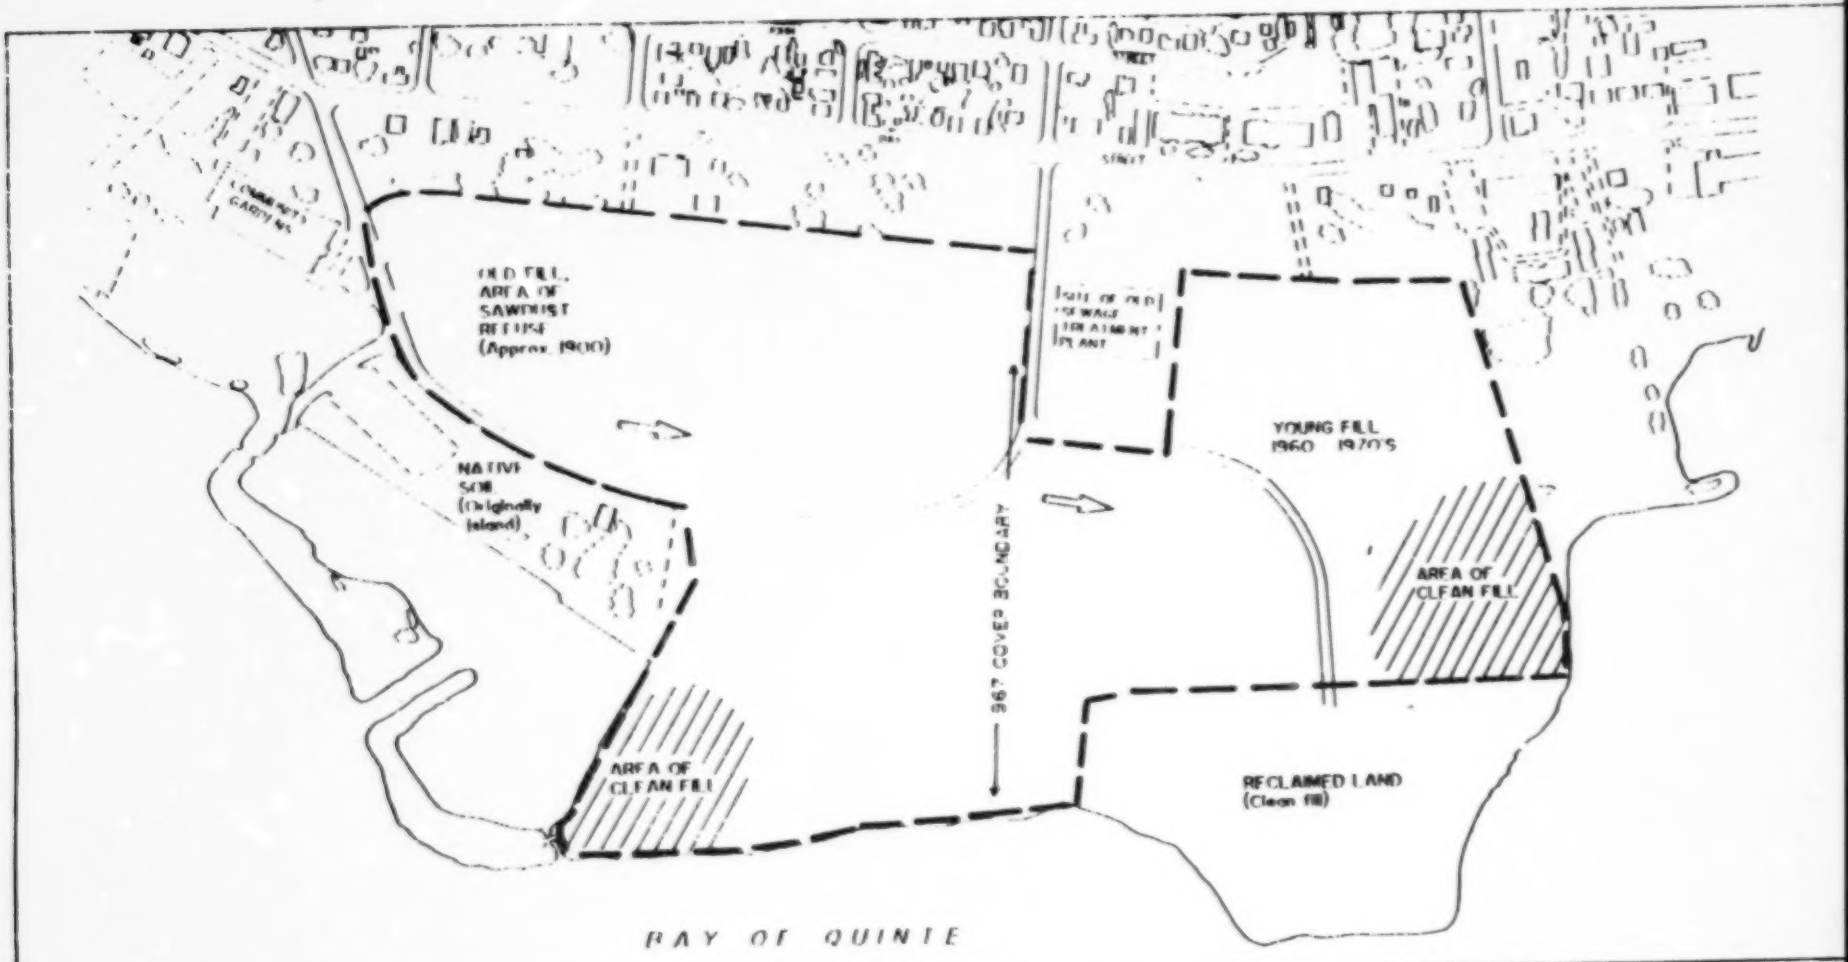
FIGURE 2

It is believed that landfill practices began in 1955 and continued until May, 1971. Site operations consisted of the construction of artificial berms of broken limestone and fine grained fill that were built in small patches onto the Bay of Quinte. The resulting lagoons were pumped out and sediment was also occasionally excavated to bedrock. The lagoons were filled with refuse and capped with pit run gravel. Some restoration was carried out as the site was filled. The site was generally filled from west to east. Figure 2 illustrates the limit of landfilling at the site.

LANDFILL DEVELOPMENT AND OPERATIONS

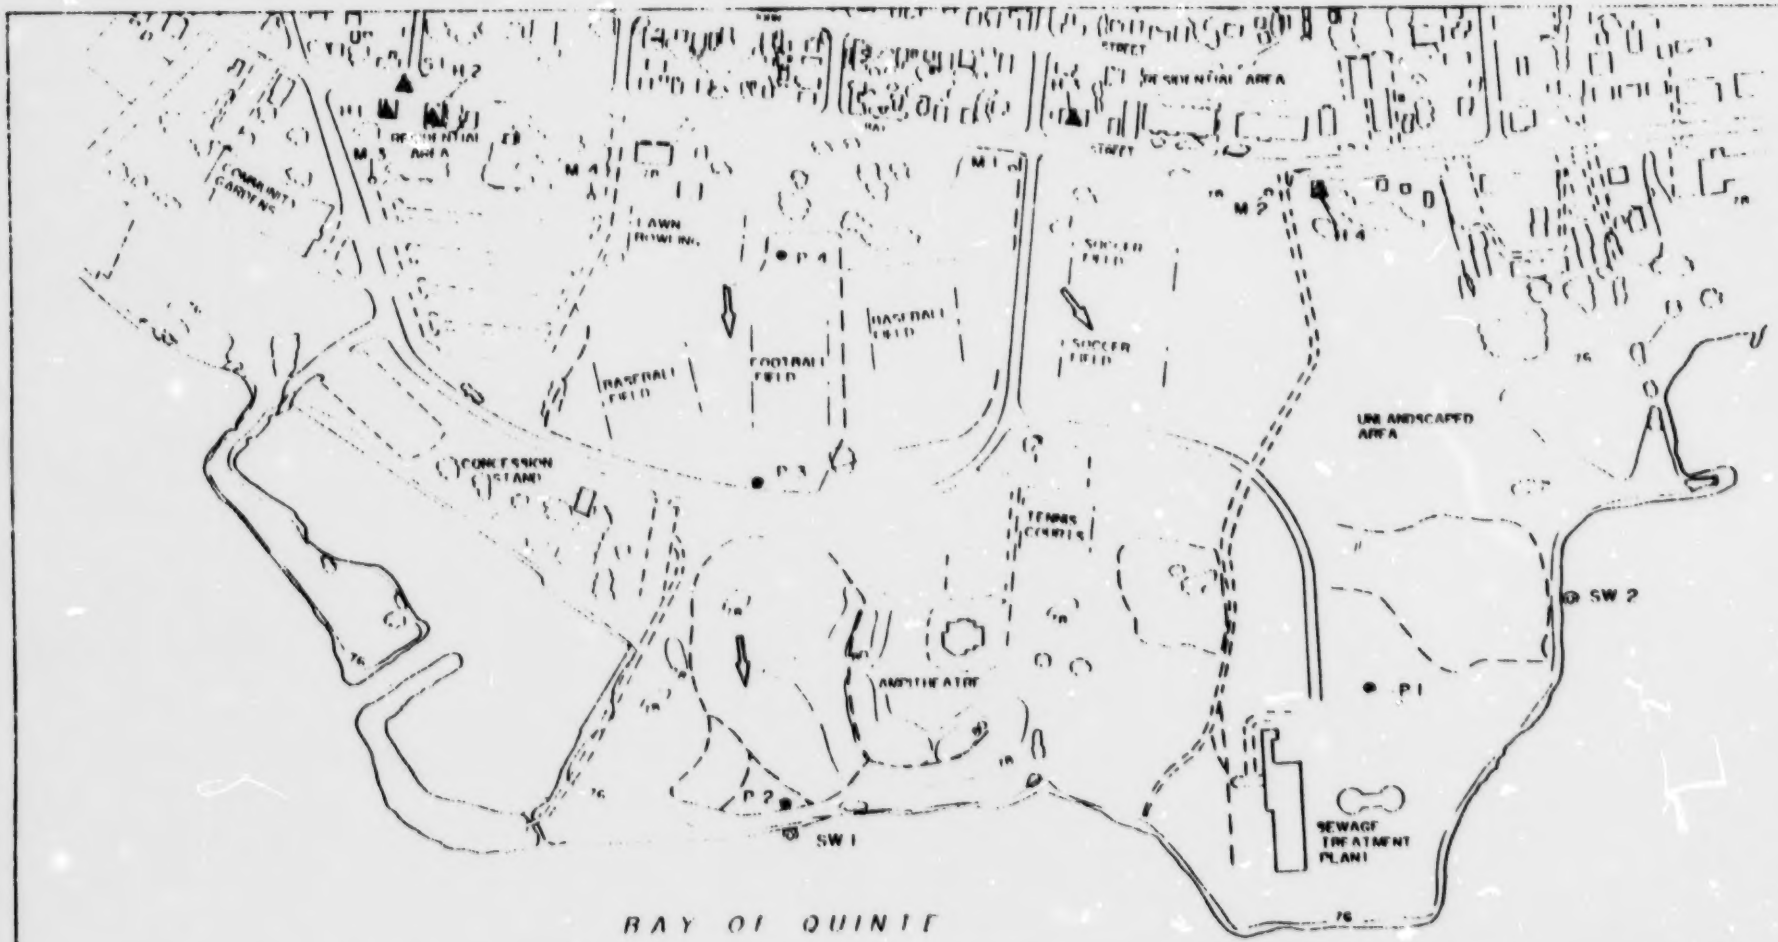
Locations of the installations are shown in Figure 3. Borehole logs showing details of each installation are found in Appendix C.

It appears that the combustible gases generated in the landfill and shown to be migrating toward the residential areas to the north and east are being dissipated into the atmosphere or possibly being intercepted and vented by service trenches in the right of way. The landfill is relatively old and it would be reasonable to assume that gas production has peaked and is declining at the site. The elevated levels of combustible gases found on the landfill side of the street would, however, suggest that development in these areas should be preceded by site specific evaluations of soil gas conditions.

1. The possibility of methane gas migration and accumulation in enclosed spaces on and adjacent to the landfill site still exists. It is recommended that the gas probes installed along Bay Street and a number of residential basements and storm sewers be monitored to observe seasonal and temporal changes in the gas concentration. Some of the sampling events should occur in the late winter when frost has been present for several months. This will be the period of maximum gas build-up.
